## FIELD INSPECTION

<b>Project Name:</b>	Mountain Valley Pipeline	<b>Inspector:</b>	Matthew Grant
<b>Inspection Date:</b>	Wednesday, January 30, 2019	<b>Project Contact:</b>	Brian Clauto
<b>Spread:</b> Franklin County MP 282 St14915+00-14900+00 Pittsylvania County MP 290 St15350-15338, MP 293 St15494+80-15458	Spread I	Weather (Wet/Dry/Rain):	Dry

## FIELD INSPECTION PHOTO LOG

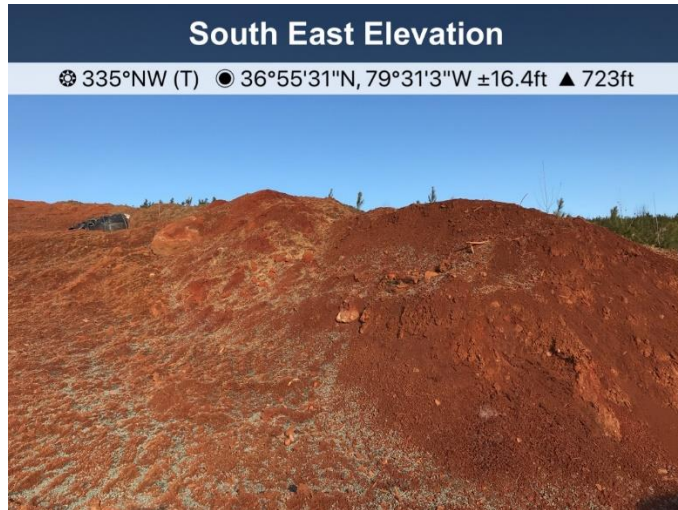
- Fig. 1 Stockpile near St#15344+00 requires additional stabilization

**Recommended Corrective Action:** Maintain and install all controls per the approved plan and specs.

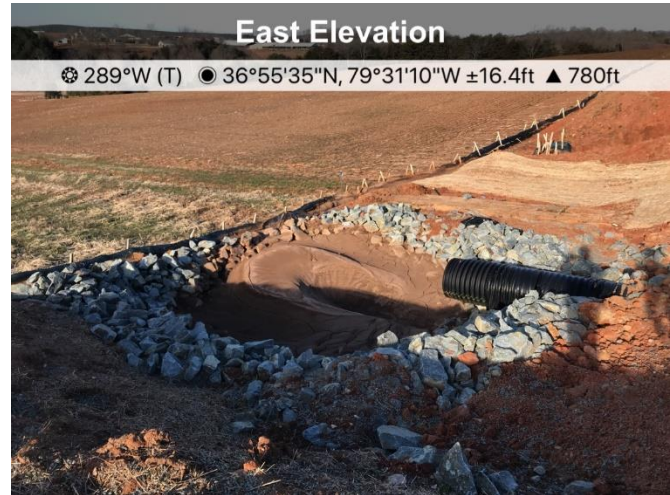
- Fig. 2 Plunge pool requires maintenance at St#15338+50

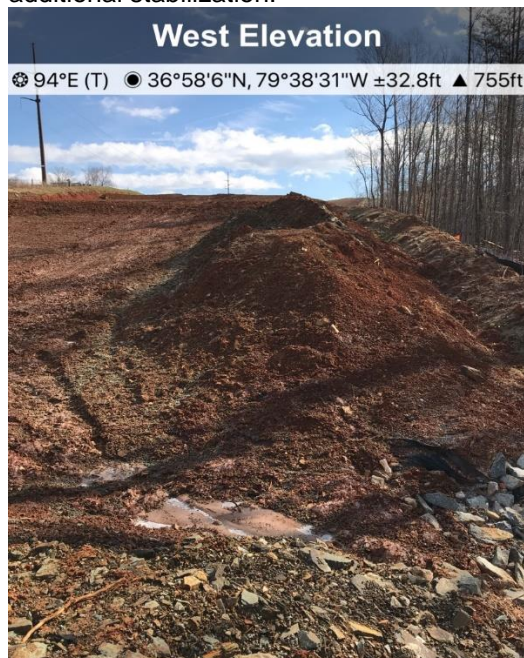
- Fig. 3 ROW and stockpiles near St#14915+00 require additional stabilization.

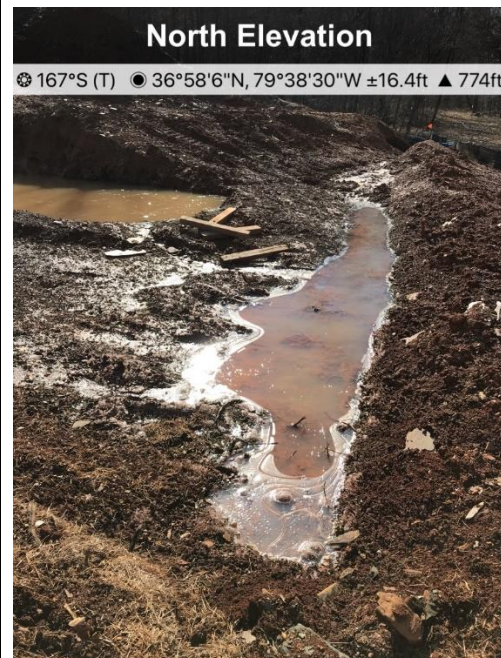
- Fig. 4 Waterbar requires maintenance at St#14916+00.

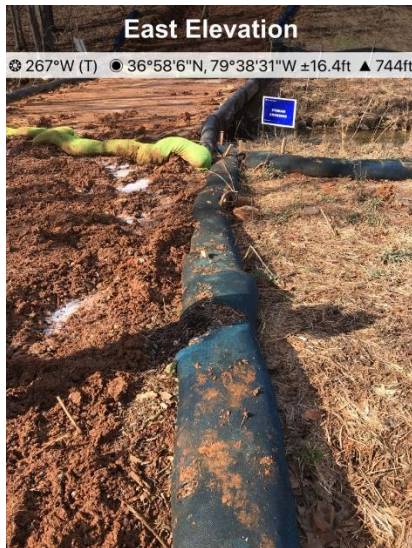
- Fig. 5 CFS at S-G16 buffer area is torn and requires maintenance.

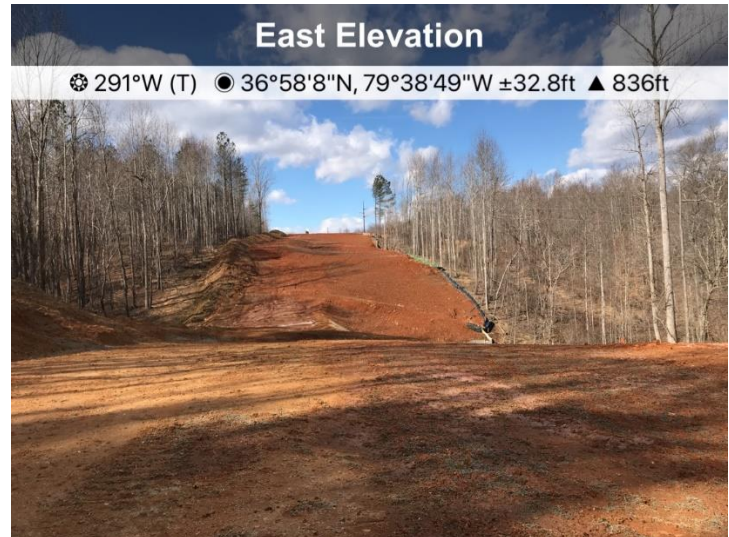
- Fig 6 Waterbars exceed 5% between 14902+00 and 14906+00.

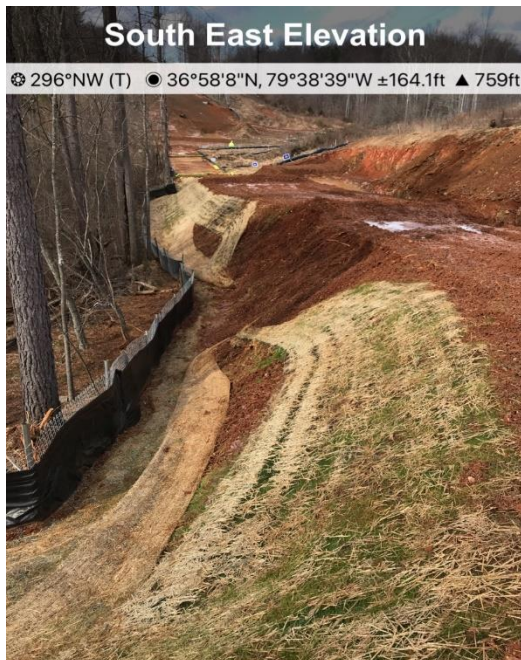
- Fig. 7 Blanket matting on side slope near St#14909+00 requires maintenance.

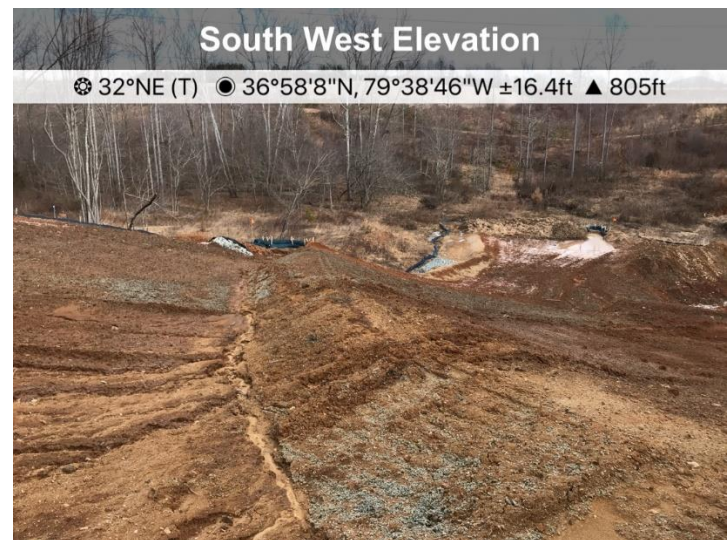
- Fig. 8 Waterbars exceed 5% between 14902+00 and 14906+00.
